Overview of the Second Quarter 2009 Surveillance and Maintenance Report for the LM Rocky Flats Site

Pond Operations – Second Quarter 2009

OLF Inspections

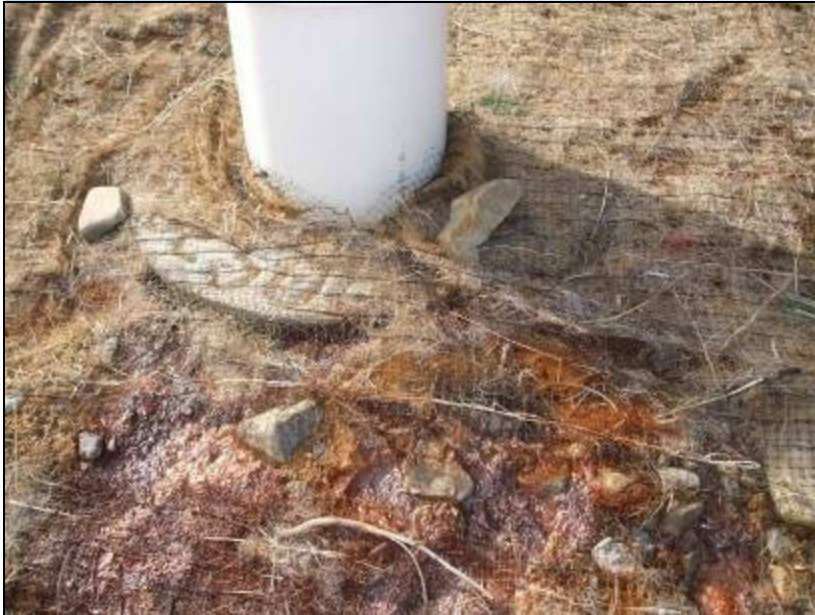
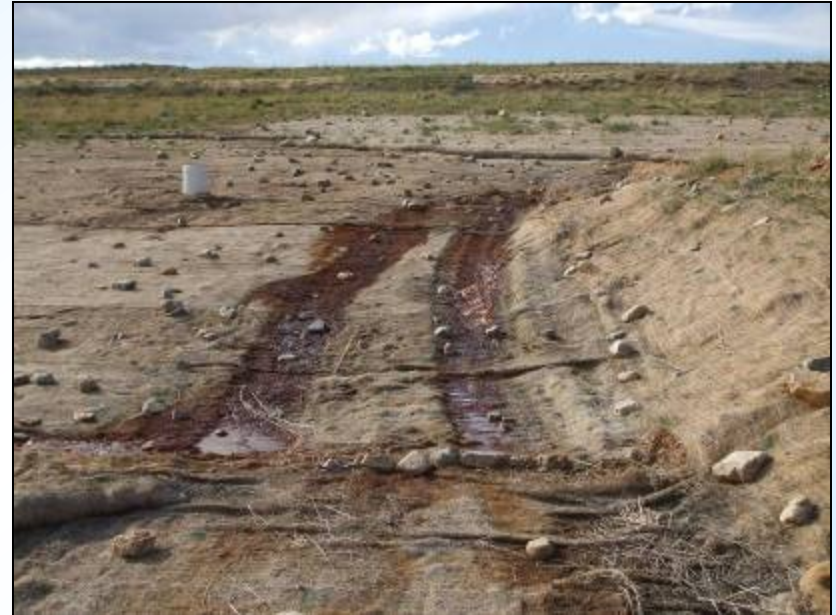
Seep 7 Expression in Spring 2009

- As part of the OLF geotechnical investigation, an extension to the original Seep 7 subsurface drain was installed in the OLF cover soil in September 2008
- No surface expression in the Seep 7 area until after precipitation events throughout second quarter CY 2009
 - Seep 7 showed surface flow during all three monthly inspections
- Flow observed along the approximate location of the eastern edge of the drain extension and south edge of casing for inclinometer 82508I
- Potholing on May 14 to evaluate the eastern edge of the drain and connection to the existing drain to determine whether water was flowing within the drain

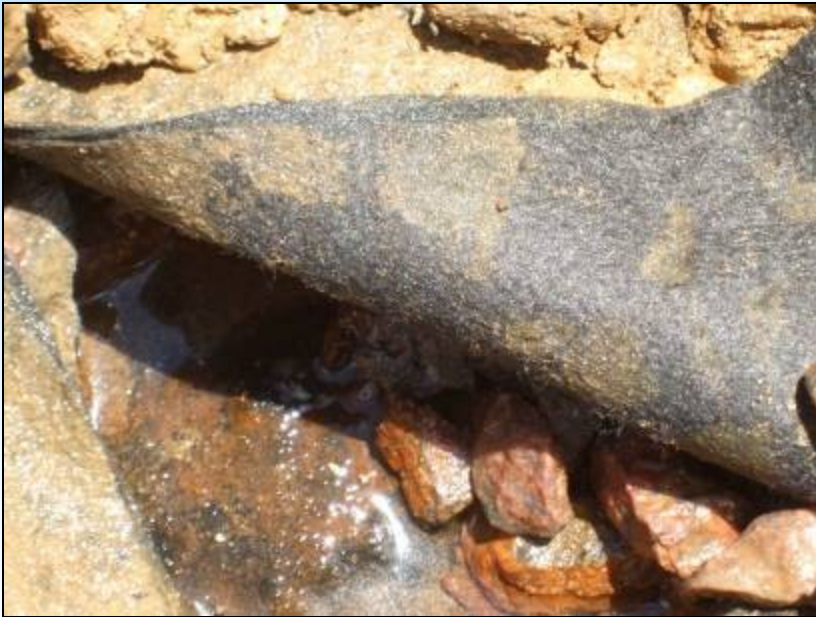
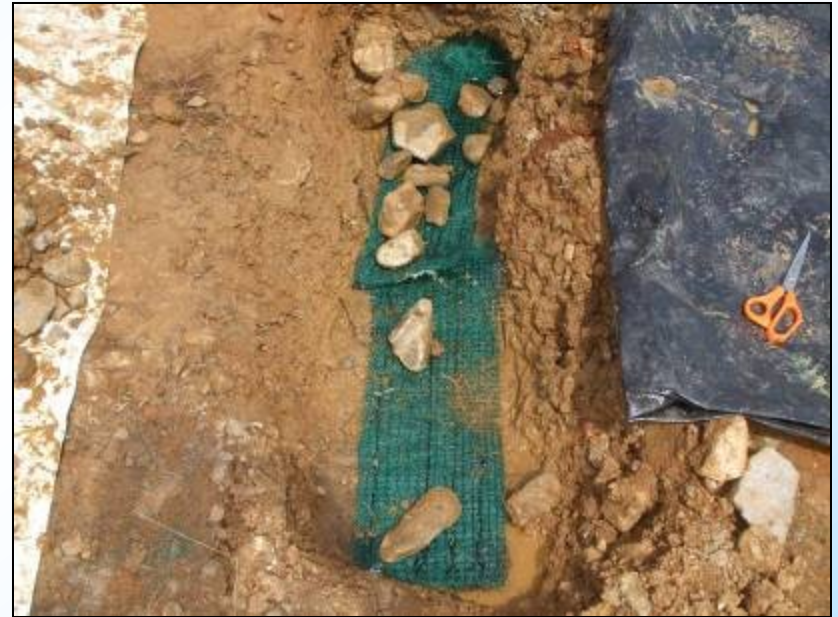
Seep 7 Potholing – Flow Inside of Geotextile Wrap; Permanent Matting Allows Water to Enter Drain

- Geotextile fabric wrap not sufficiently porous to allow water to seep into the drain fast enough to carry the water away
- Seepage was surfacing in the vicinity of the eastern edge instead
- Water was freely flowing inside the drain extension and carrying water that enters the drain in the subsurface
- Small section of the geotextile wrapping edge replaced with more porous permanent erosion matting, which immediately resulted in the water entering the drain and the surface area quickly drying up at this location
- Additional sections along the edge adjusted in similar manner to allow water to enter the drain

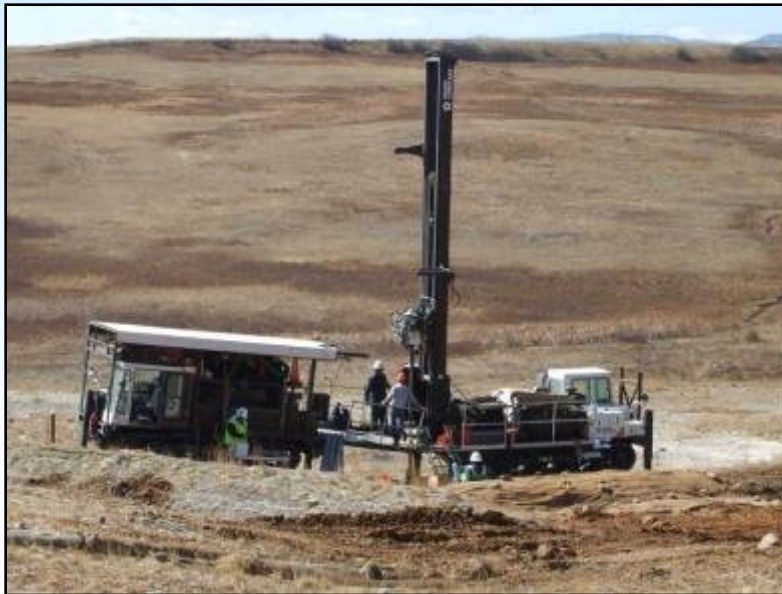
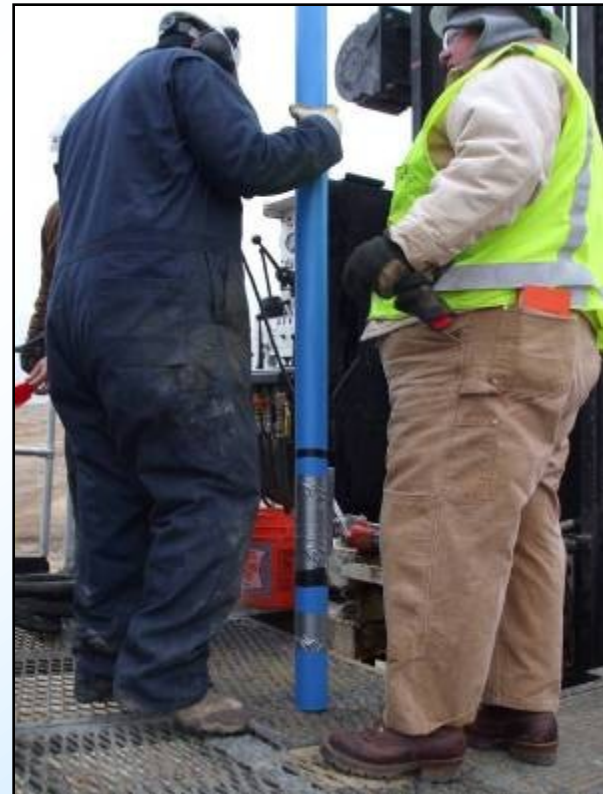
OLF Inclinator Deflection

- Settlement monuments were surveyed on June 23; data are within the expected range per the OLF Monitoring and Maintenance Plan
- Inclinometers were measured on April 29, May 13 and 14, and June 11 and 16, 2009
- Results showed higher deflection for several inclinometers, most noticeable for the three inclinometers on the west side of the OLF, between diversion Berms 1 and 3 (inclinometers 82208I, 82308I, and 82408I) where deflection was approximately 1.5 to 2.25 inches

- Seven inclinometers installed in boreholes in 2008 during OLF geotechnical investigation
 - Inclinometers deflect with lateral ground movement

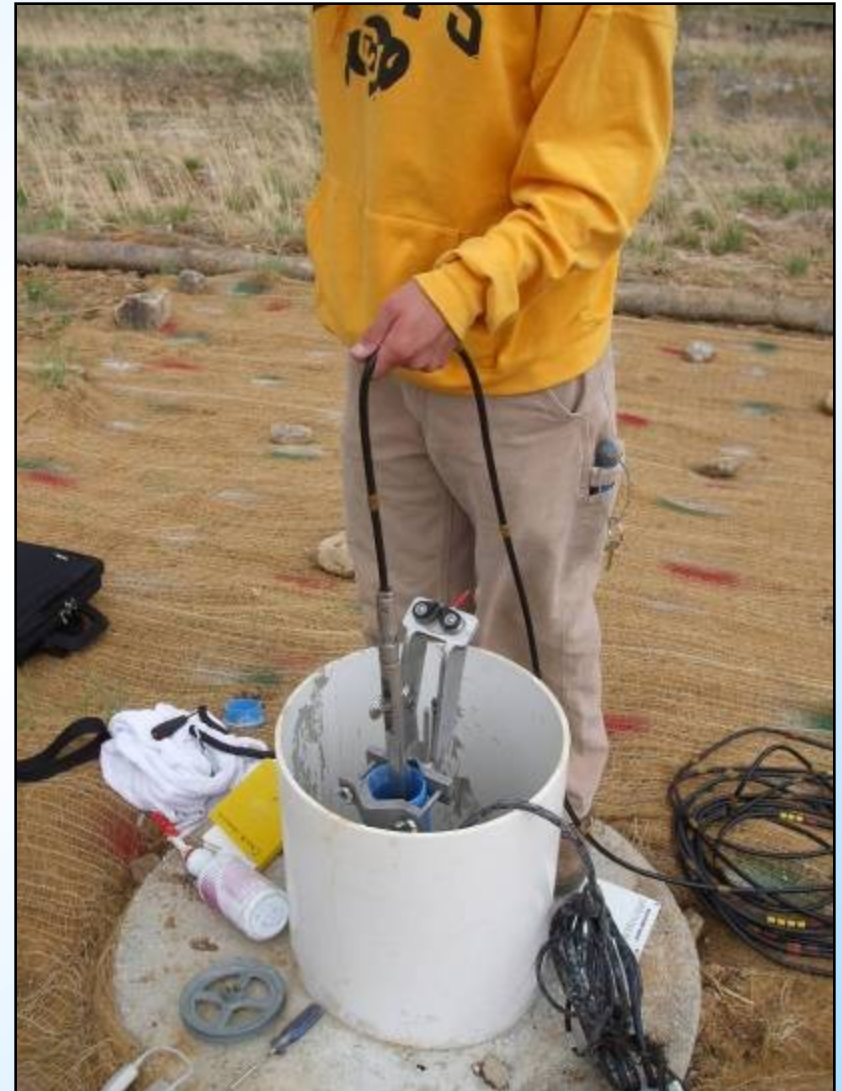
OLF Inclinometer Deflection (continued)

- Movement of the inclinometers has been monitored approximately monthly since installation

- Deflection occurred after a period of heavy precipitation events beginning in April 2009
- Deflection appears consistent with findings from geotechnical investigation: organic layer near bedrock creates weak zone for overlying soil. When lubricated by subsurface moisture from precipitation events, localized movement of the surface soil may occur.
- A qualified geotechnical engineer is evaluating further inclinometer data
- Indicated that signs of localized movement on the cover surface may occur – slumping noted

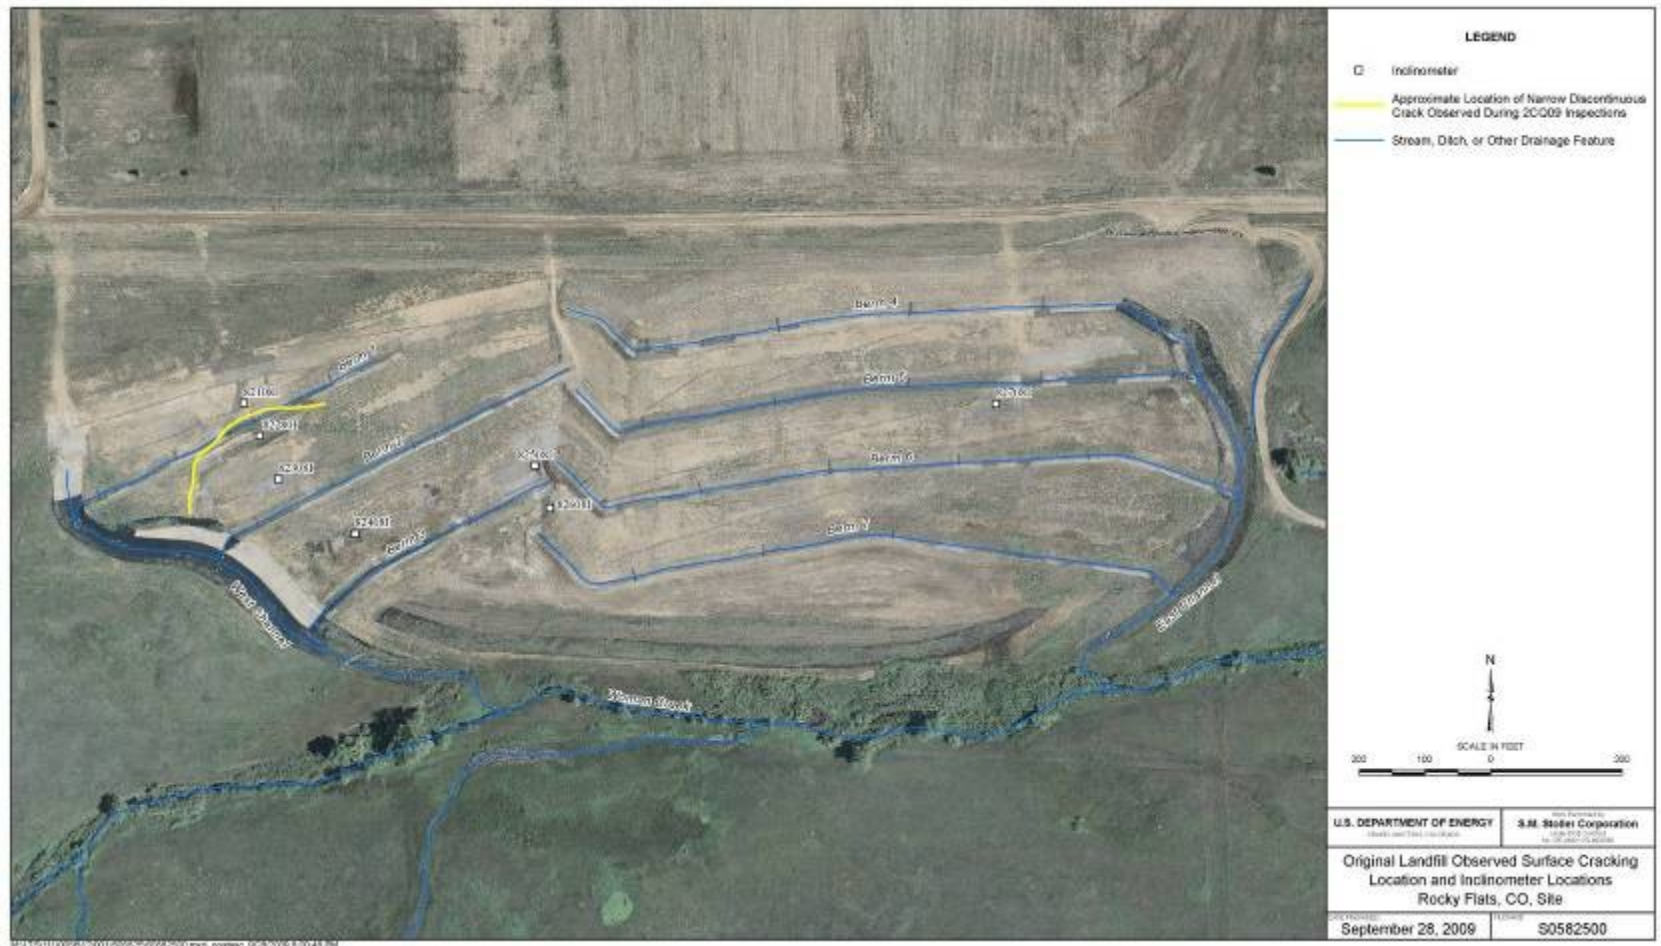
OLF Observed Crack Location

- Areas where the landfill cover is pushed up or rolling are noticeable on the western end of the OLF between Berms 2 and 3; however, the areas do not have any surface cracks at this time
- A new crack in Berm 1 was observed on April 4, 2009. The crack extended for a short distance through diversion Berm 1 to the north side of the berm and then back to the south side of the berm.
- These cracks were in the same general location of large cracks that appeared in 2006 and 2007
- Completed West Perimeter Channel regrading and channel drain in 2008 to improve stability. Slump not as severe as that noted in 2007.

- Continue maintenance actions to fill cracking to minimize infiltration of precipitation
- The main crack in Berm 1 was observed again on June 20, 2009
- Site staff again repaired the crack with hand tools and the ATV bucket
- Subsequent nonroutine inspections have shown no new movement in the area where the crack was repaired
